## Borescope Inspection Report

28/09, 2019

Unit A  
ESN 481-012

GE project 1999123 / 2897805

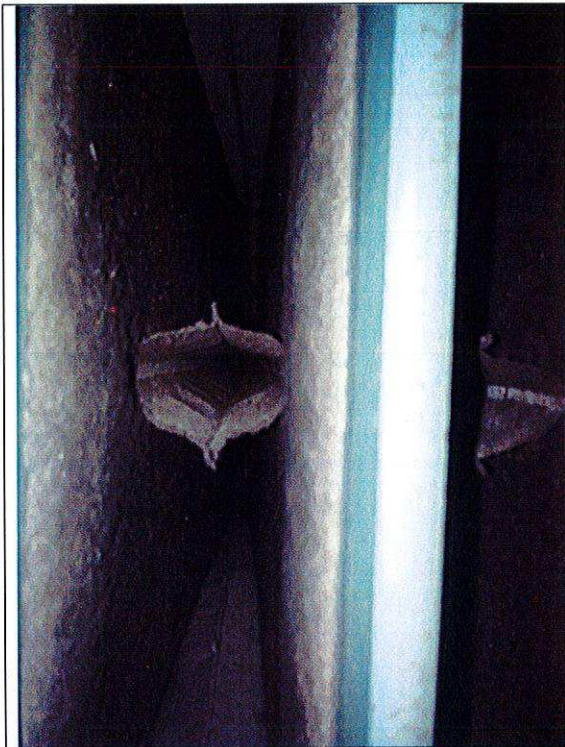
With the Filter house inspection found the filter dirty, a change of the filter needs to be done soon.

Found Filters dirty

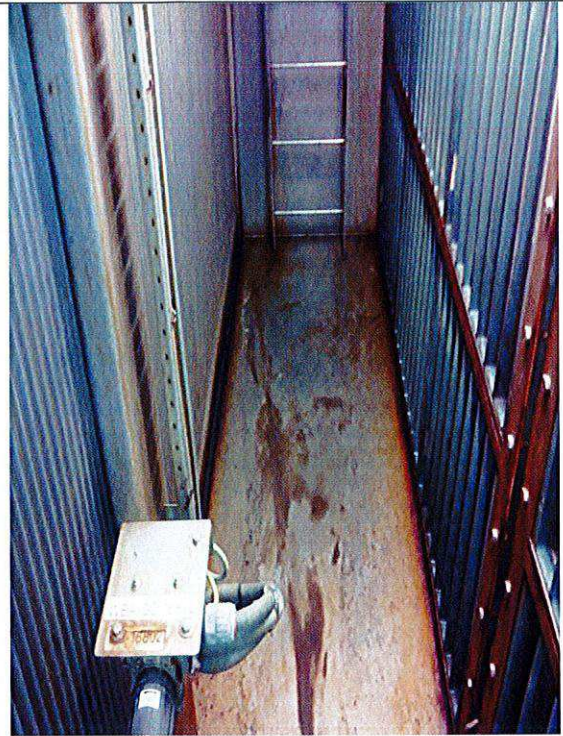
Found dust on Filter house floor before filters

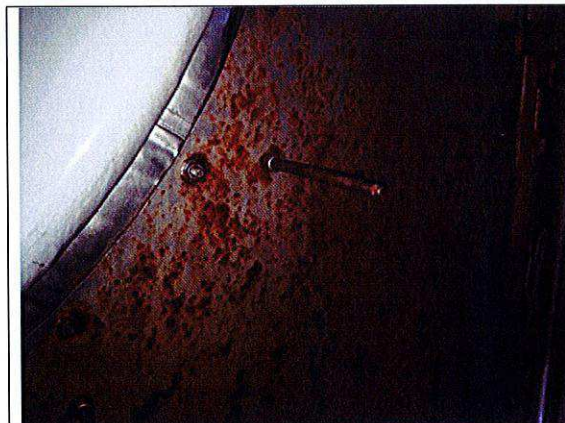
Inlet inspection. (some corrosion on the inlet wall)

Corrosion on inlet wall

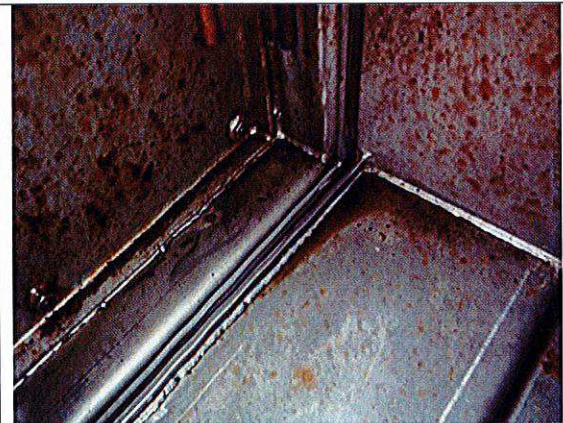
Found some oil in the air inlet, inlet will be cleaned after the water wash by the costumer reps.

Found oil in Air inlet

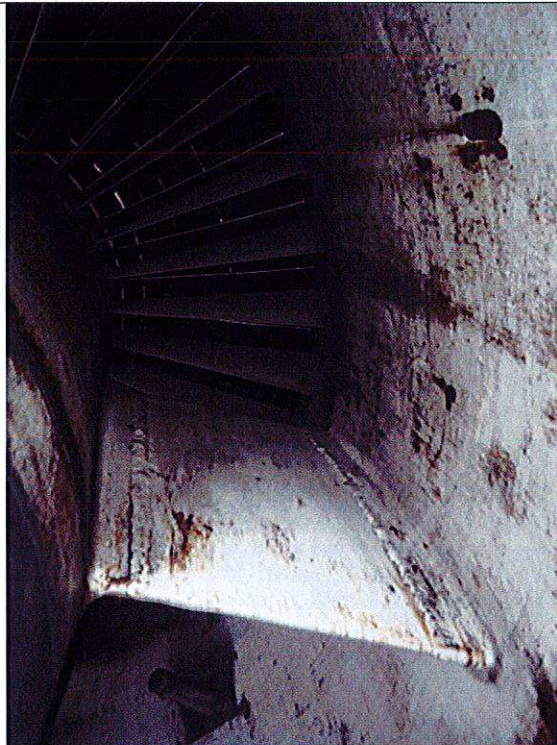
Engine inlet looks dirty

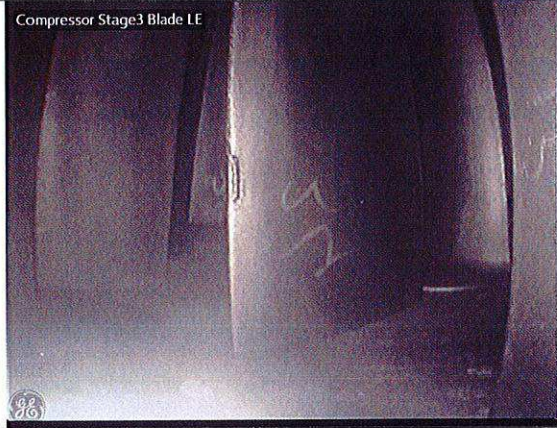
<p>Stage 3 LE dirt build up</p>	<p>Compressor Stage4 Blade TE</p>

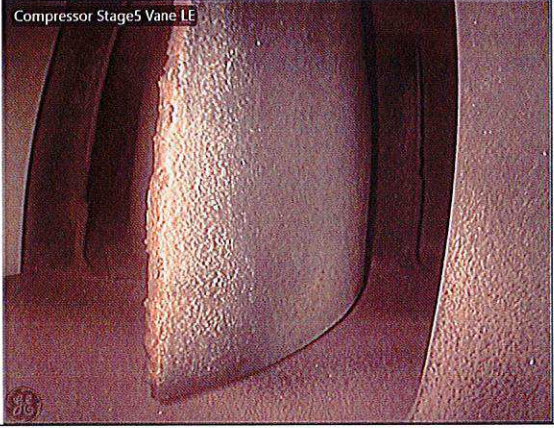
<p>Compressor Stage 5 Vane LE</p> <p>Stage 15 LE Dirt build up</p>
