GAS TURBINE SERVICES

Borescope Report – SGT100

Information	
Customer: Mærsk Olie & Gas AS	Service Centre: Gas Turbine Services A/S
Address: Britaniavej 10 6700 Esbjerg	Address: Service Department Murervej 2-6 6710 Esbjerg V Denmark
Site Location:	Contact:
Report to: [redacted] Olsen	Siemens contact:
Telephone:	Telephone:
Telefax:	E-Mail:
E-Mail:	E-Mail:
Turbine Info	
Turbine Type: Typhoon	Operating Hours: 39121
Turbine Duty: Generator	Recorded Starts: 2198
Engine Serial No.: 9100/111 core sn RM272	
Original Sales Order No.: M466/01	
Customer Order No.: SO 3500151730	Service Order No.: 201235
Remarks:	
Boroscope Inspection on	
Period of visit	Service Personnel
From: 19/09-2016	Name
Until: 21-09-2016	1. [redacted] teer
	2. [redacted]
	3. [redacted]
	4. [redacted]
	5. [redacted]

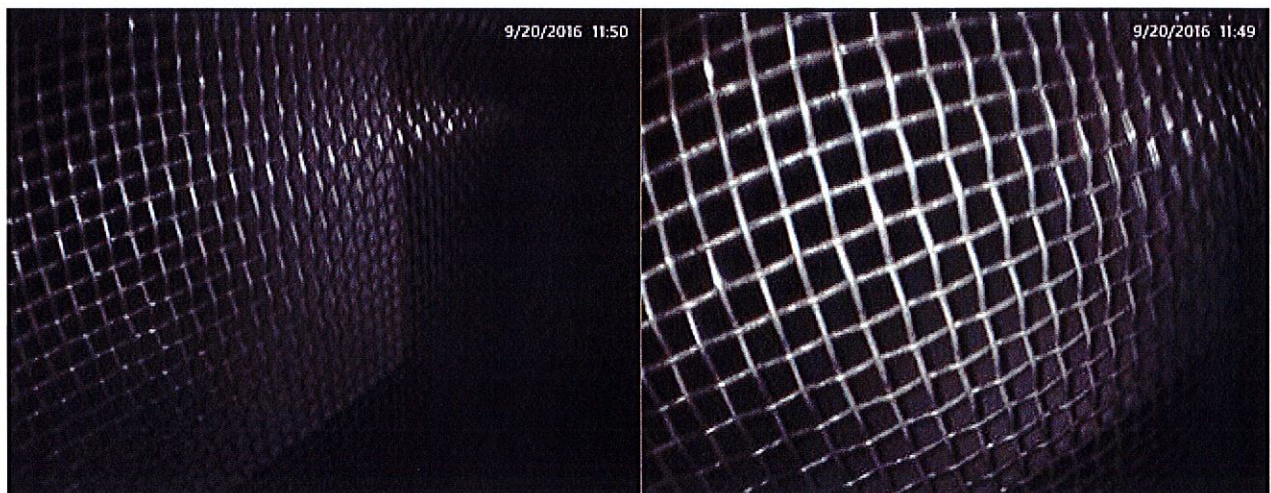
1.0 Air Inlet Screen:

Notes: Good condition. No objects found on the screen

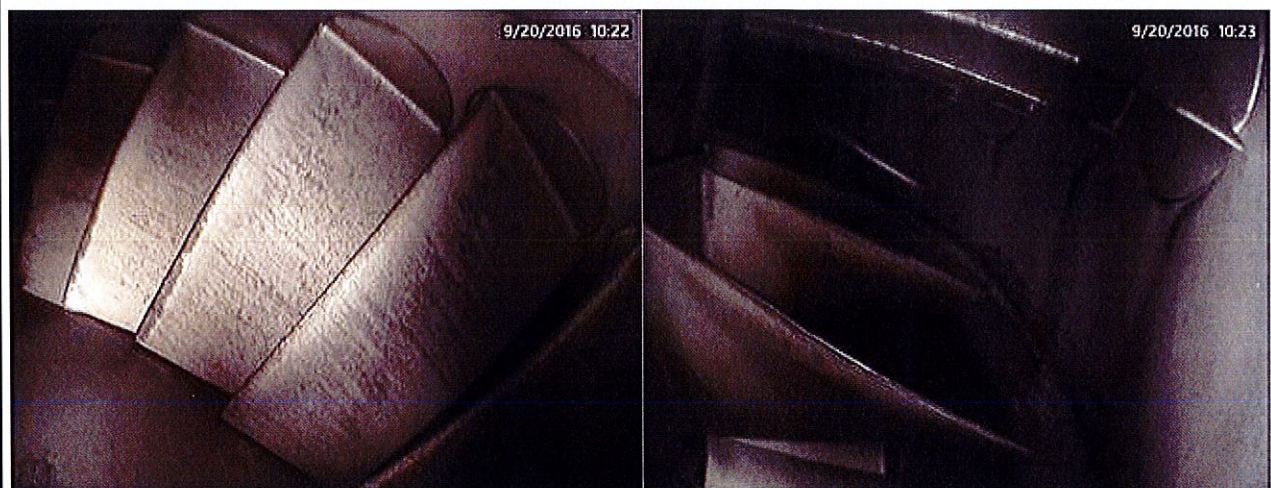
2.0 Inlet guide vanes

Notes: Good condition. Clean.

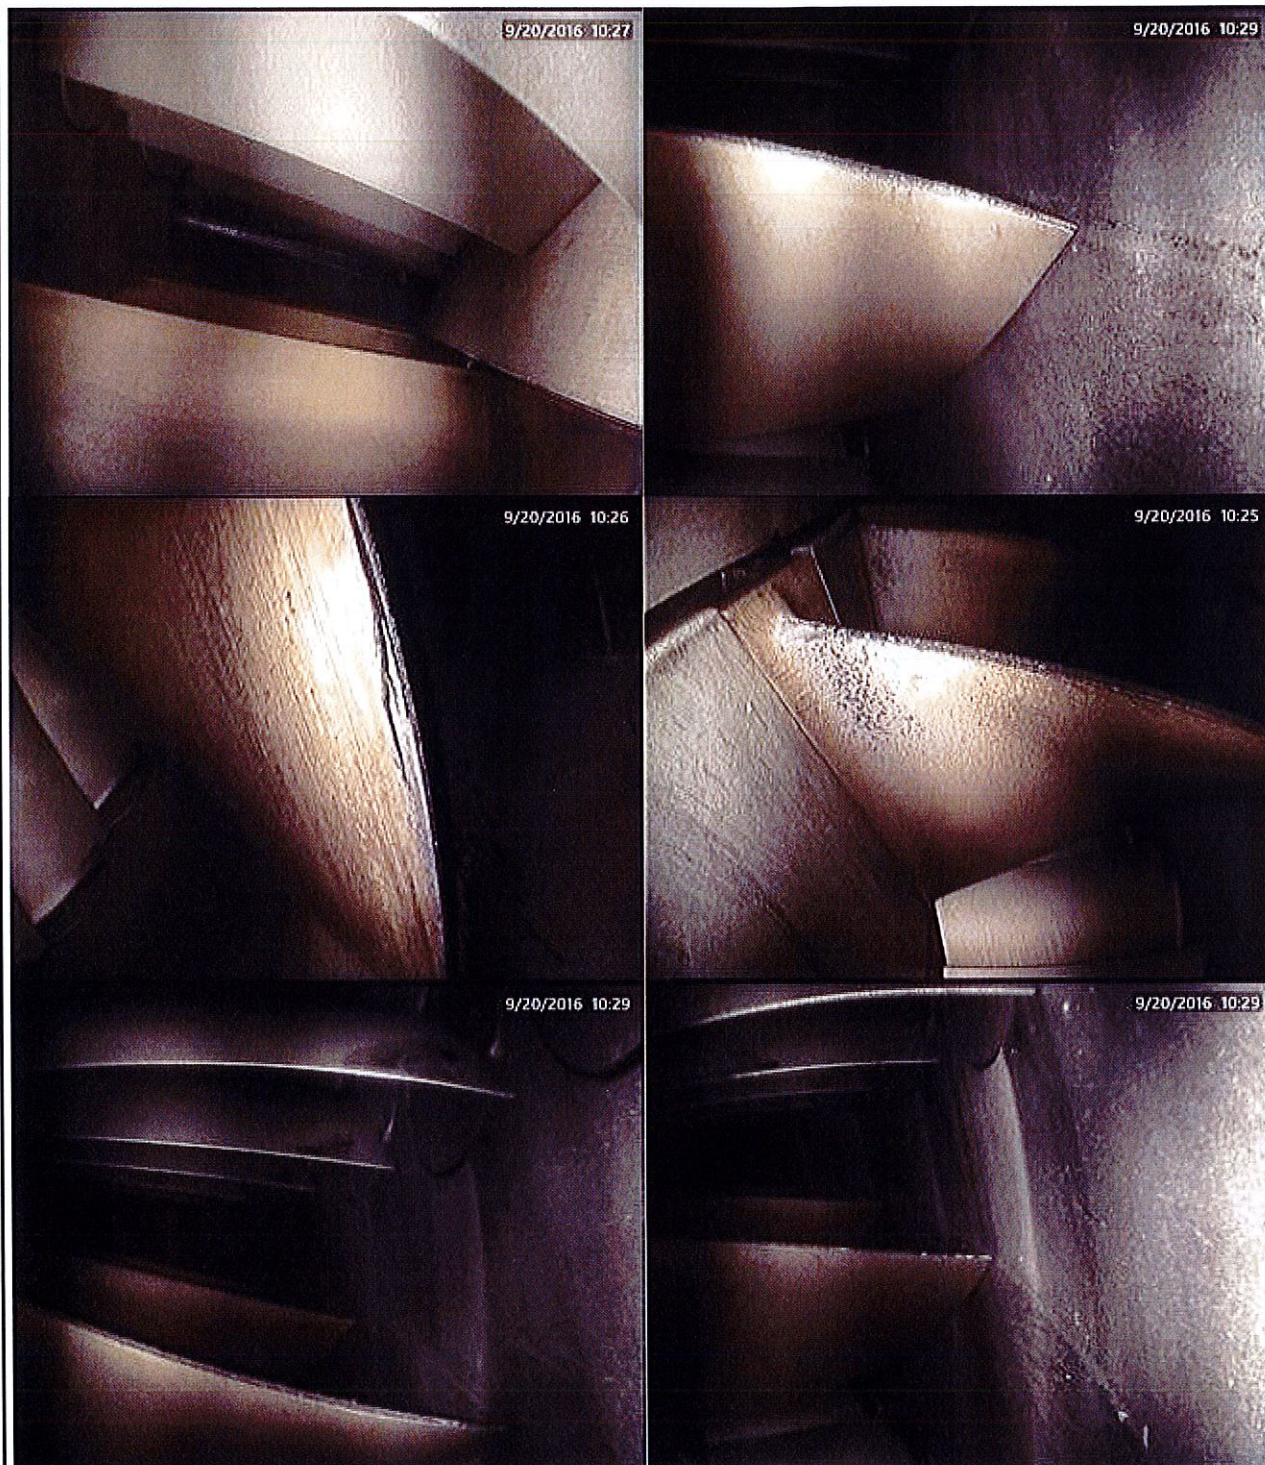
3.0 Stage 1 Compressor Rotor

Notes: Good condition. Clean. No FOD damage. Slight coating loss on the leading edge and root of blade.

The compressor looks like it has ingested some particles at some point. It could have come from nearby sandblasting. It is nothing major, it has just left some wear patterns in the compressor coating.

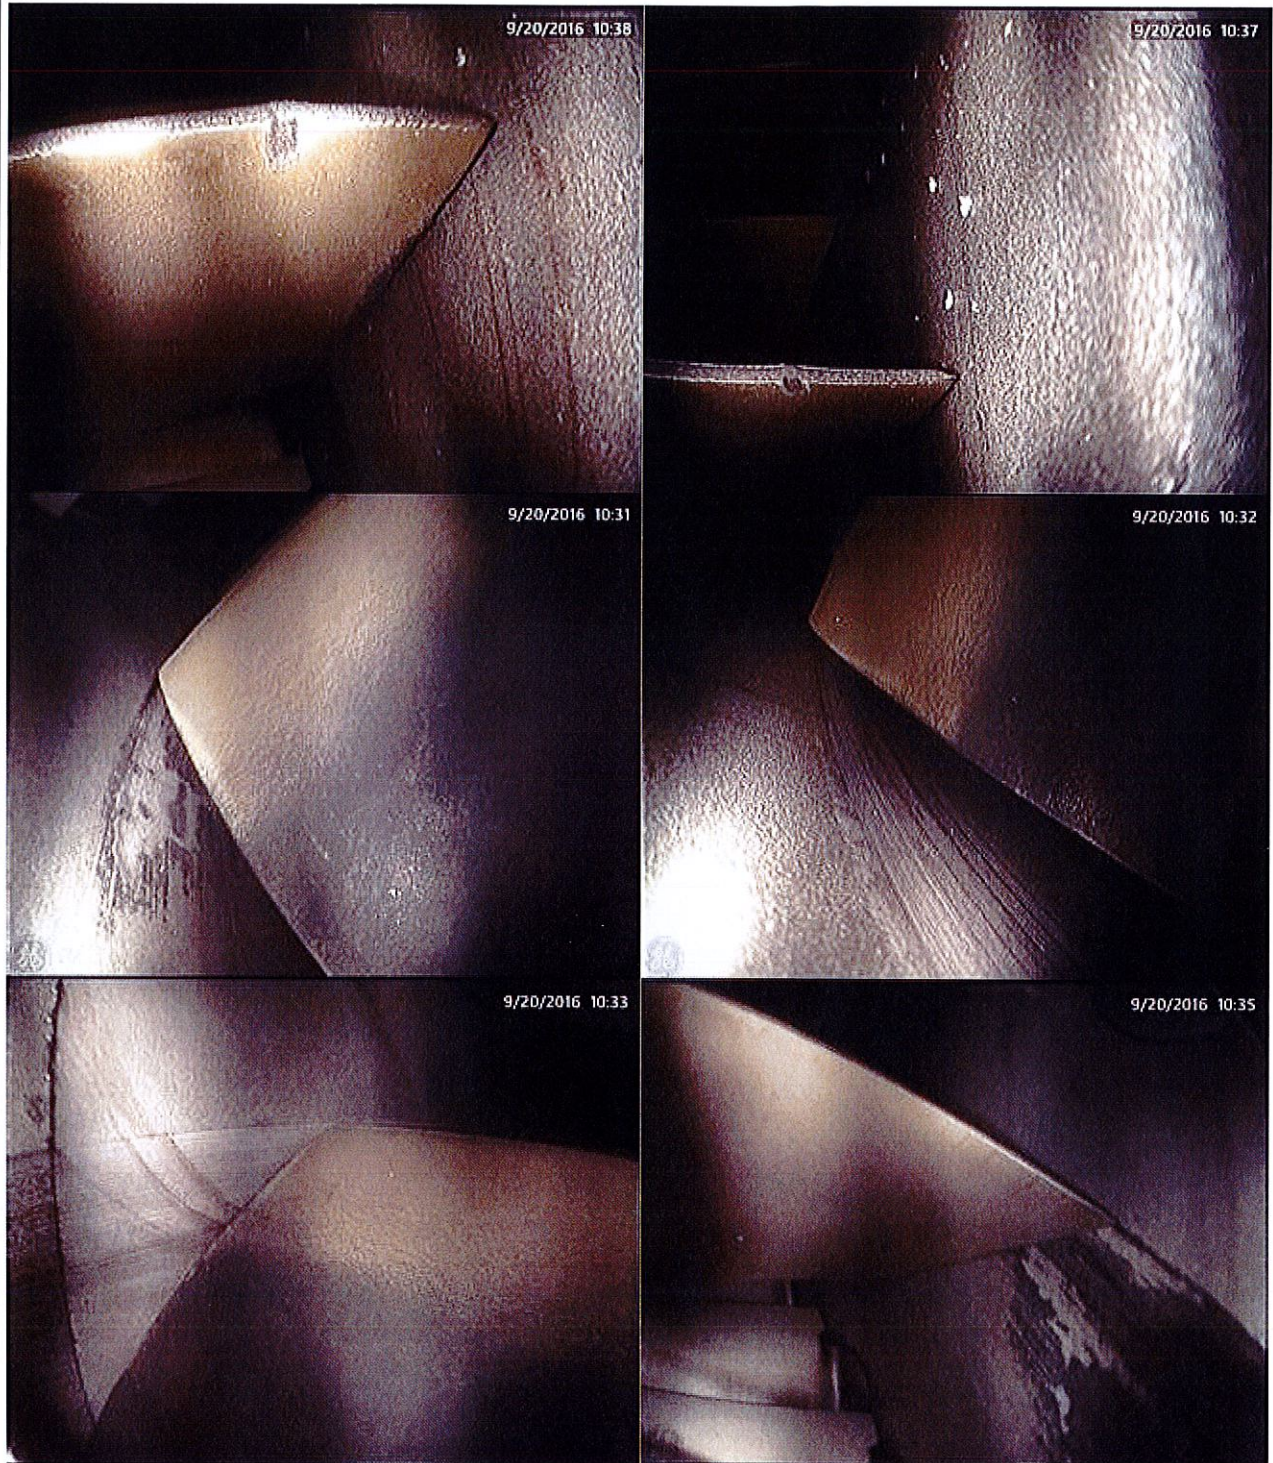
4.0 Stage 2. Compressor rotor

Notes: FOD damage on one of the blades. There is a small amount of tip rub. Also slight coating loss on the casing.
Slight coating loss on blade leading edge

The tip rub in compressor stage 2 and 3 could be as a result of the increased vibration during hot starts. The vibration levels under normal operation is ok.

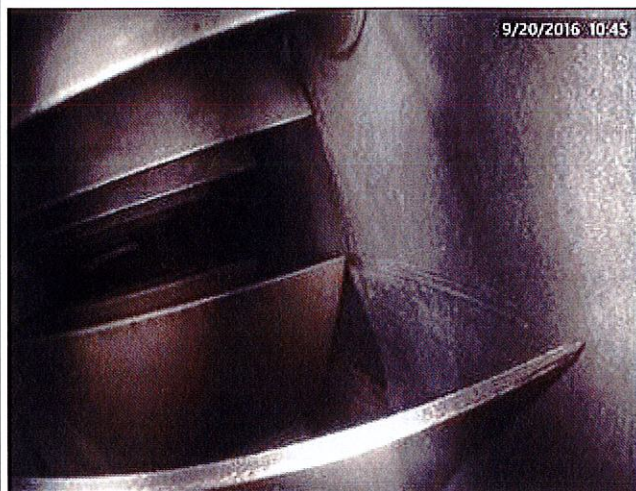
5.0 Stage 3 Compressor rotor

Notes: Good condition. no FOD damage. Small amount of tip rub.
Slight coating loss on leading edge.
Good clean condition.

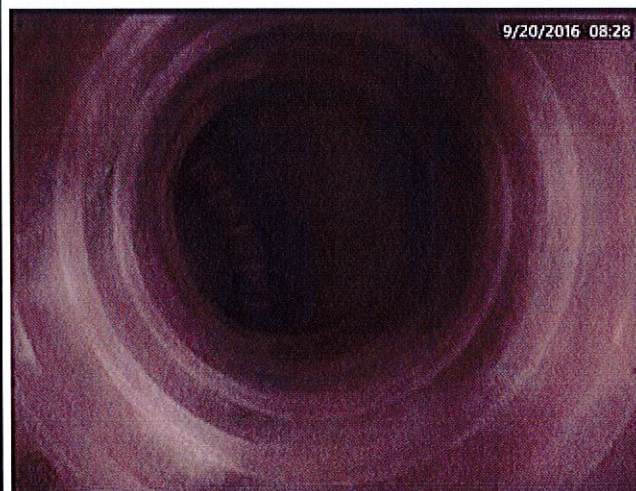
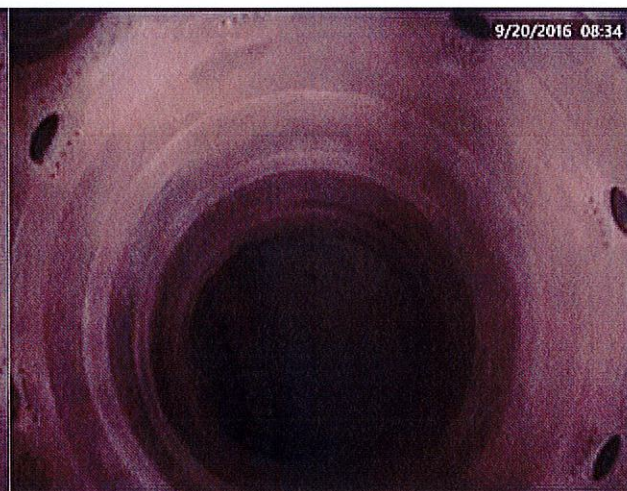
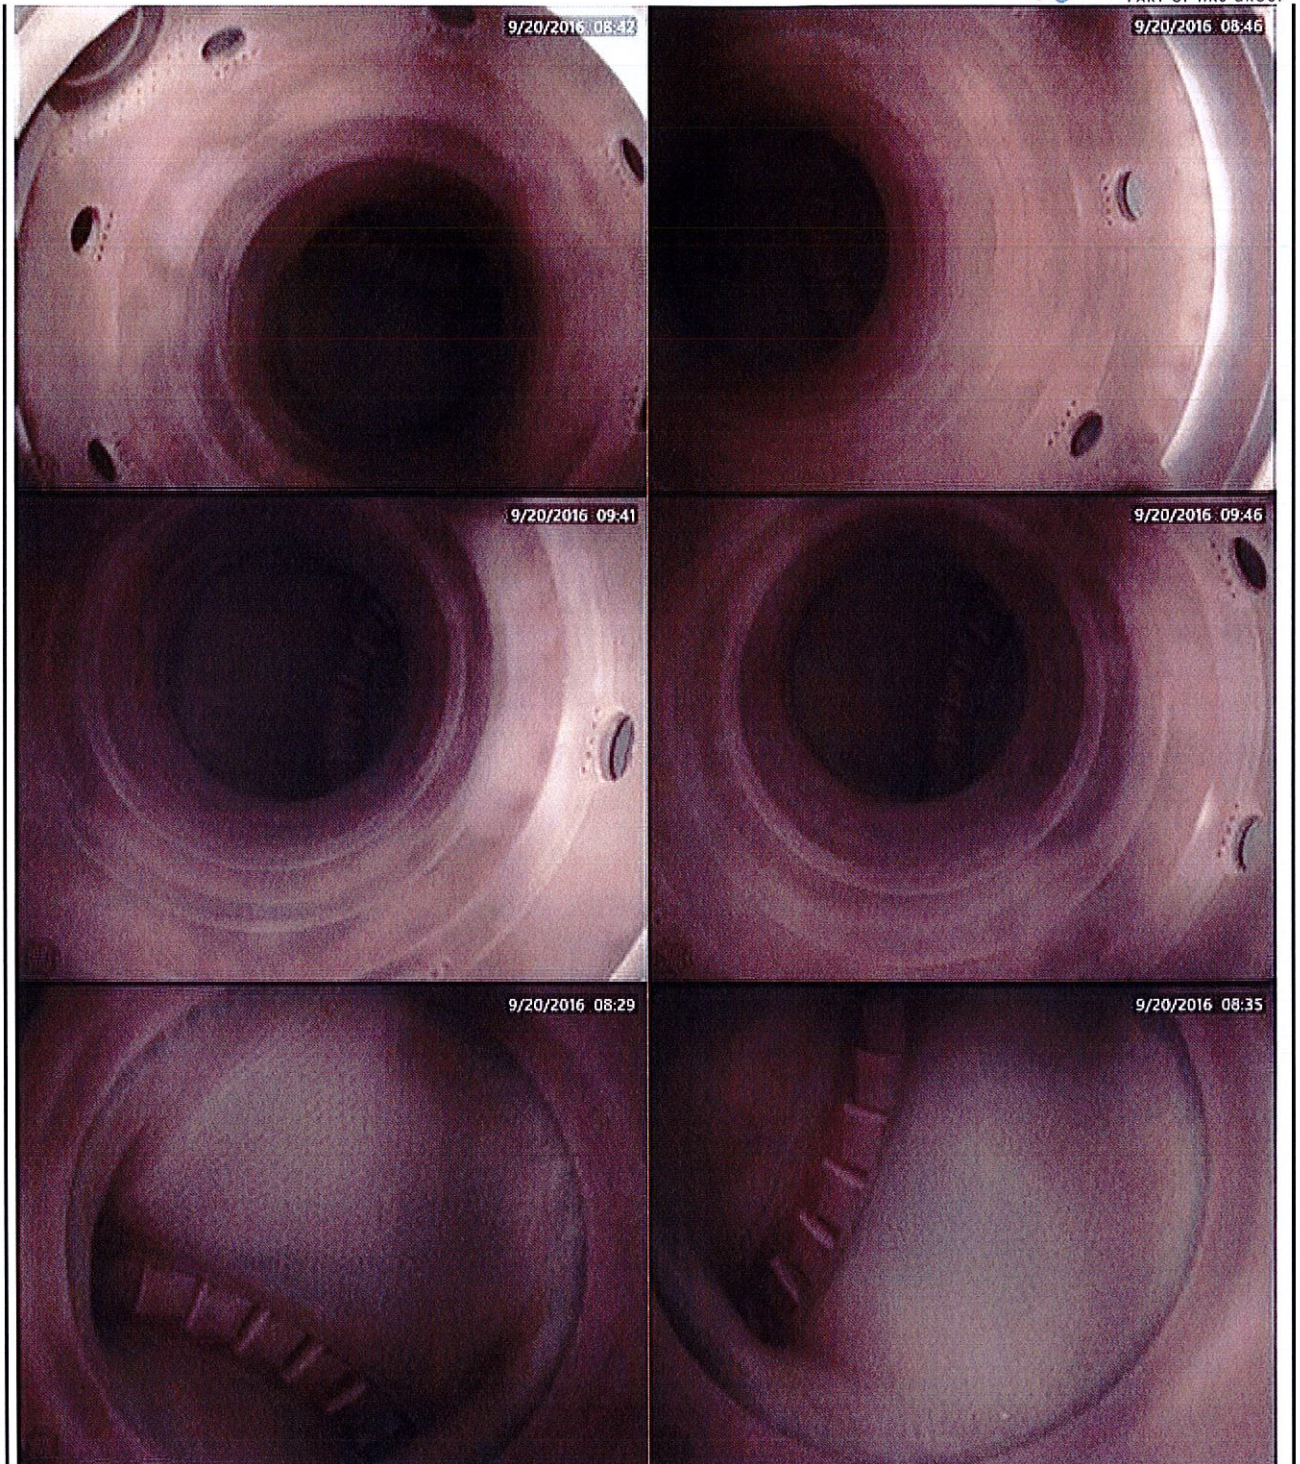
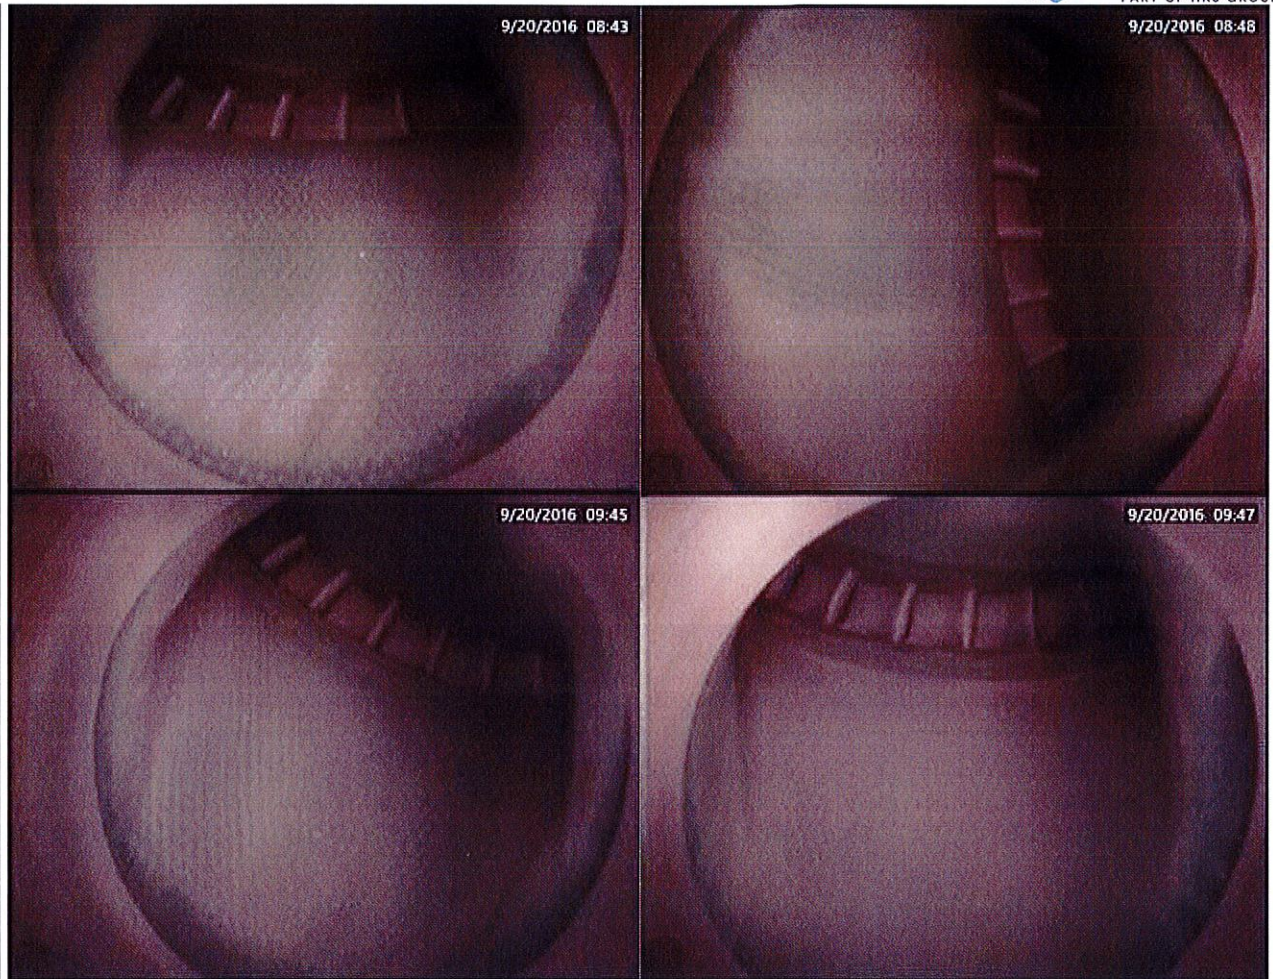
6.0 Flame tubes and transition Ducts

Notes: All looks in good condition. No coating loss, cracks or distortion.

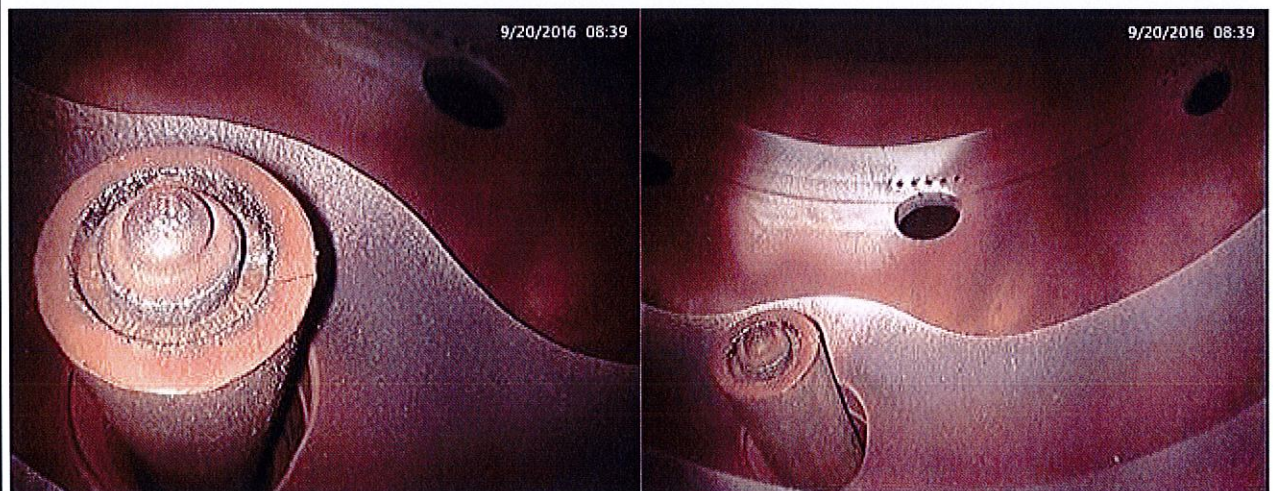
6.2 Igniter Tip

Notes: Good condition

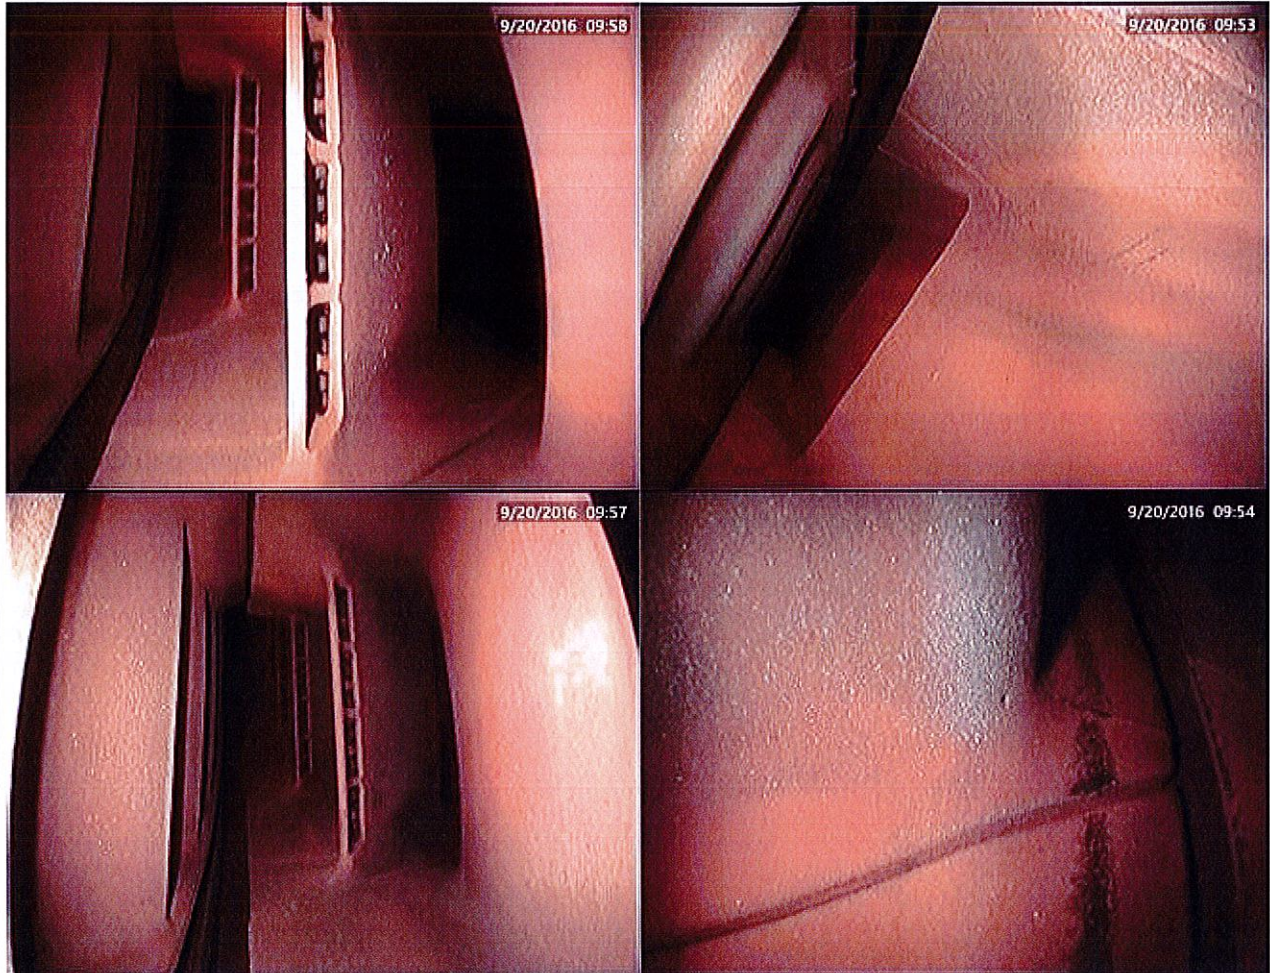
7.0 HP rotor and stator inspection

Notes: Looks in good condition. No heat erosion or cracks. Small amount of particle build up on the HP nozzles and the leading edge HP rotor blades.

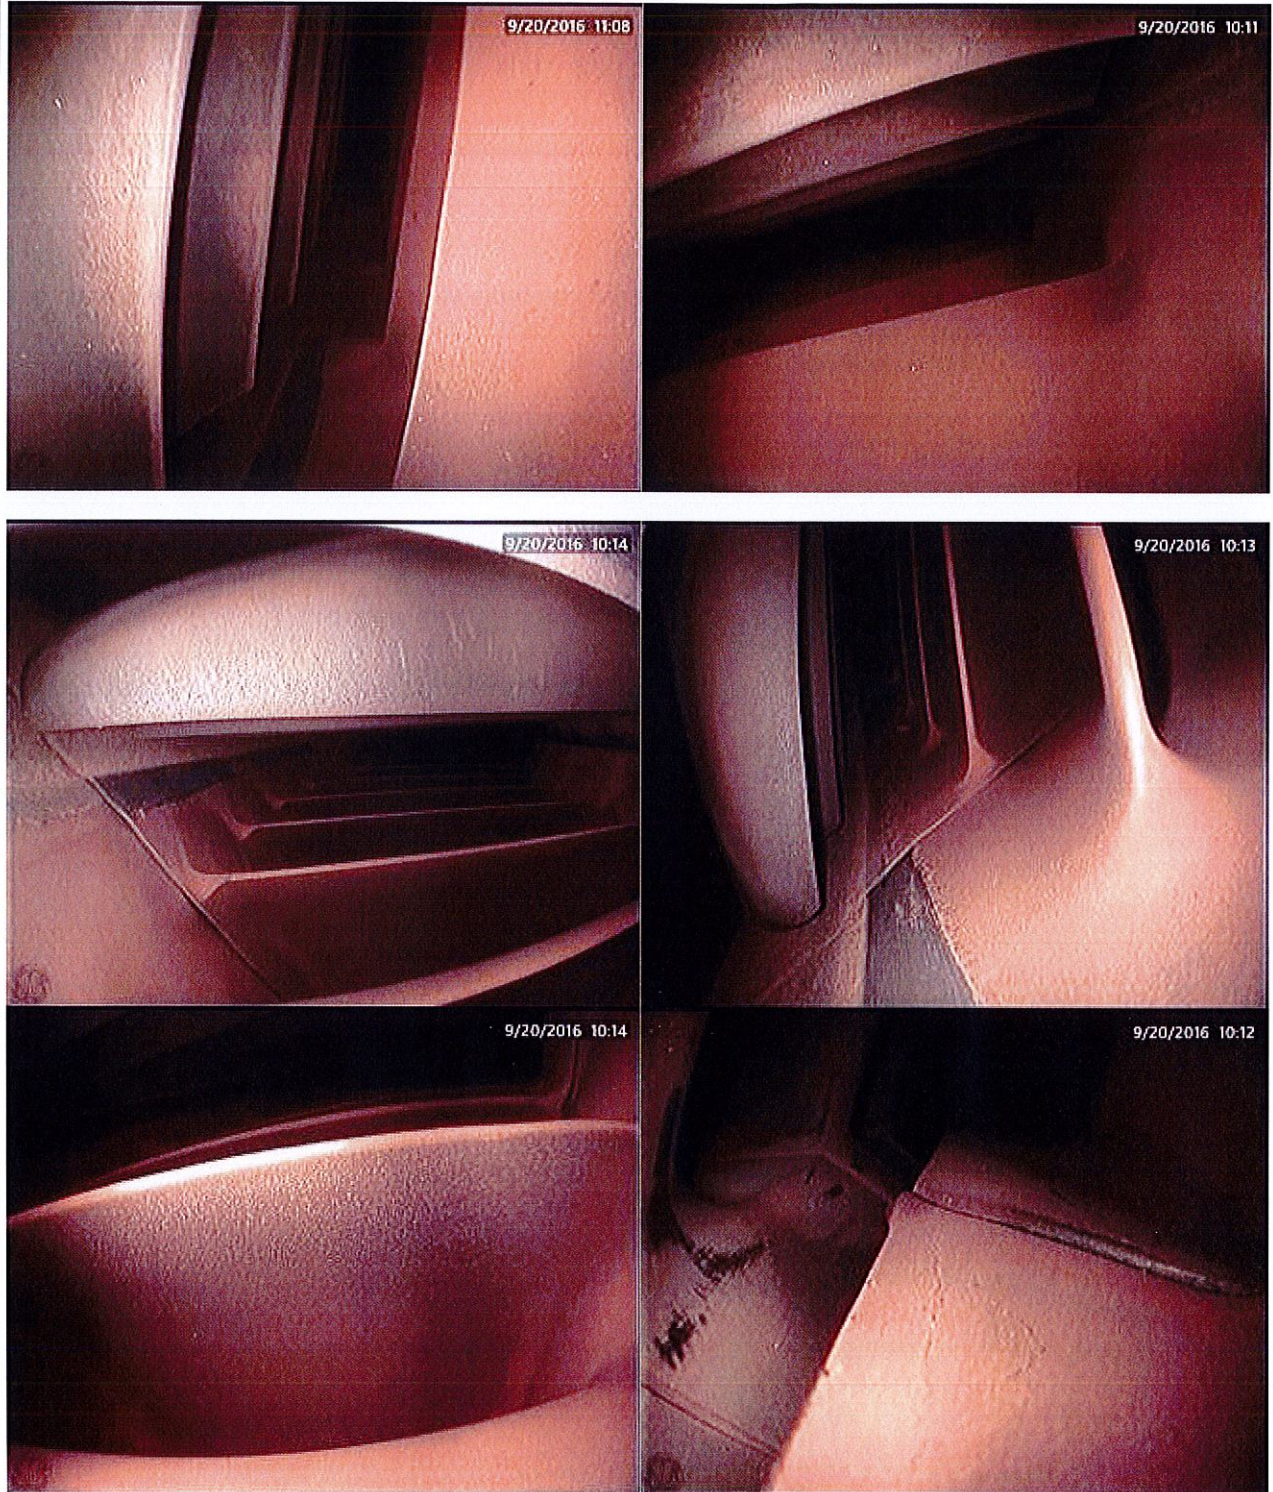
8.0 LP stator and rotor inspection.

Notes: Looks in good condition.

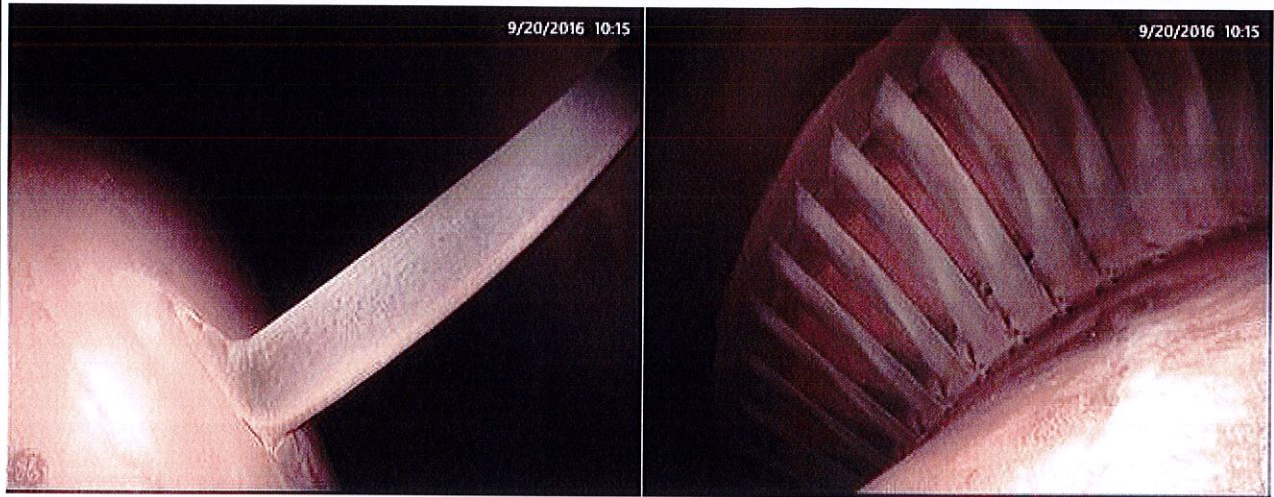
9.0 Exhaust gas exit areas

Notes: No remarks
