Engine Removal \ Installation Report

Aug 15 , 2018

ESN 481-723 Removed

ESN 481-724 Installed

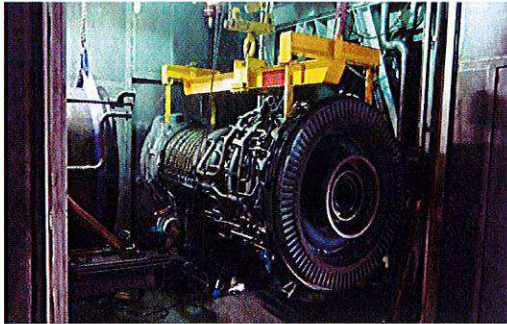
Old engine removed (481-723)

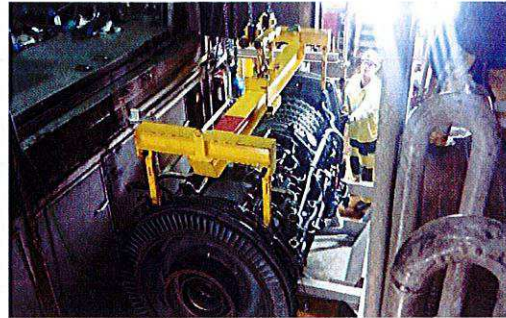
Old engine placed in dolly

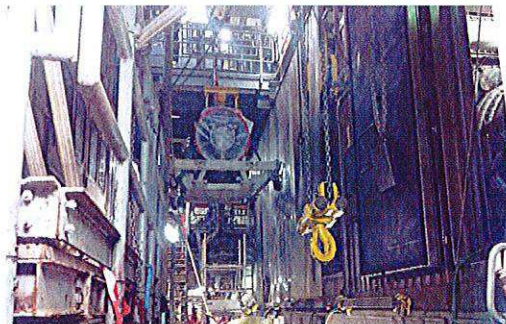
New engine (481-724) lowered from upper deck

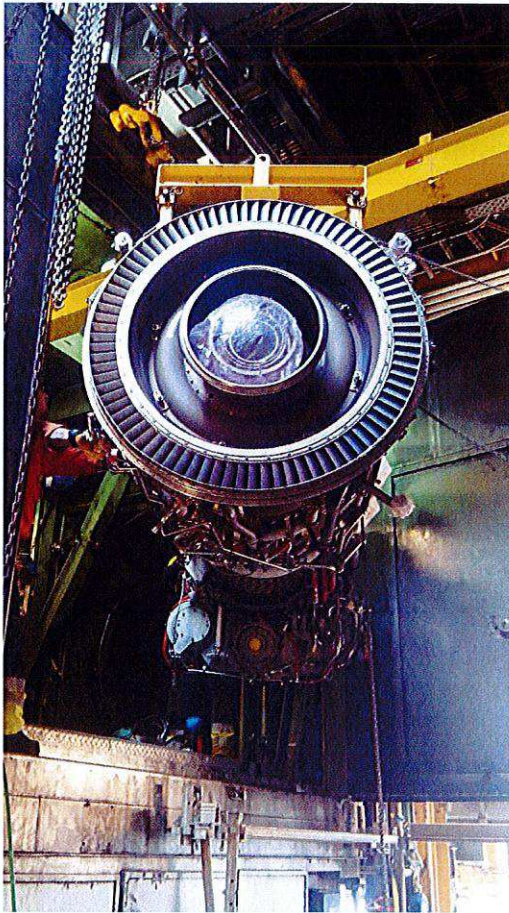
New engine into enclosure

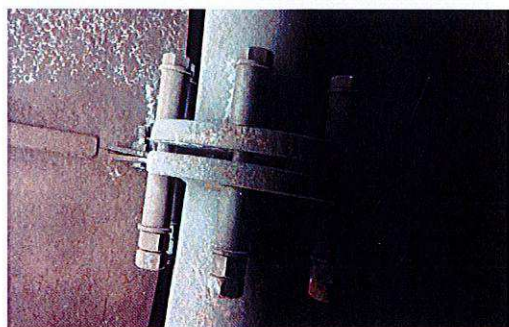
On inspection of exhaust it was seen that on the anti-vibration ring some of the bolts had come loose and began fretting against the flange, customer informed and they shall carry out repair

Loose bolts on Anti vibration ring

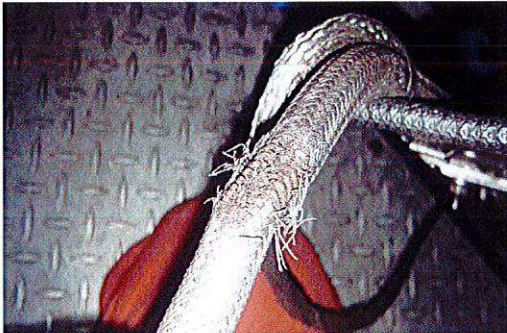
Damaged Ignitor cable

Description	PN Removed		Qty		PN Installed	SN Installed
Ignitor cable			1		9600M37P13	
Ignitors			2		100002494	
Starter gasket			1		100002693	
Starter o-ring			1		J221P222	
Nut			96		9610M50P02

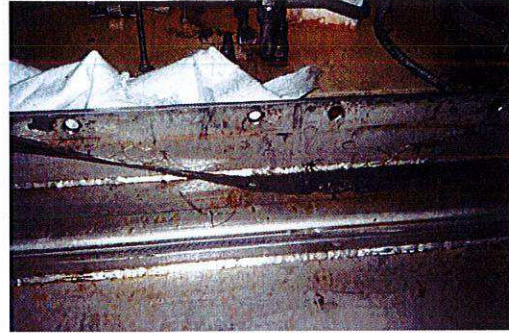
Old gasket ,plenum door

- Engine removed 481 723 and placed in a trolley
- Package floor cleaned
- Engine lifted up to container deck and placed in the container
- The new engine 481 724 lifted from the container to a trolley outside the enclosure
- The new engine installed
- Inlet plenum floor cleaned
- New gasket on the inlet plenum door
- Found a damage on one of the ignitorcables.Changed it to a new one.
- Two of the attach/clamps on the vent hoses was not properly attached, this was fixed
- Inspection of the exhaust(customer)
- Changed two syntetic oil filters (supply,scavenge)
- VSV calibration/schedule
- HP Recoup calculation
